May 21, 2015

RE: Cooper Site Building - 350 Downie Street, Stratford, ON
Roofing Components Visual Review
Including Hazardous Materials Abatement Costs

RJC No.: TOR.103282.0012

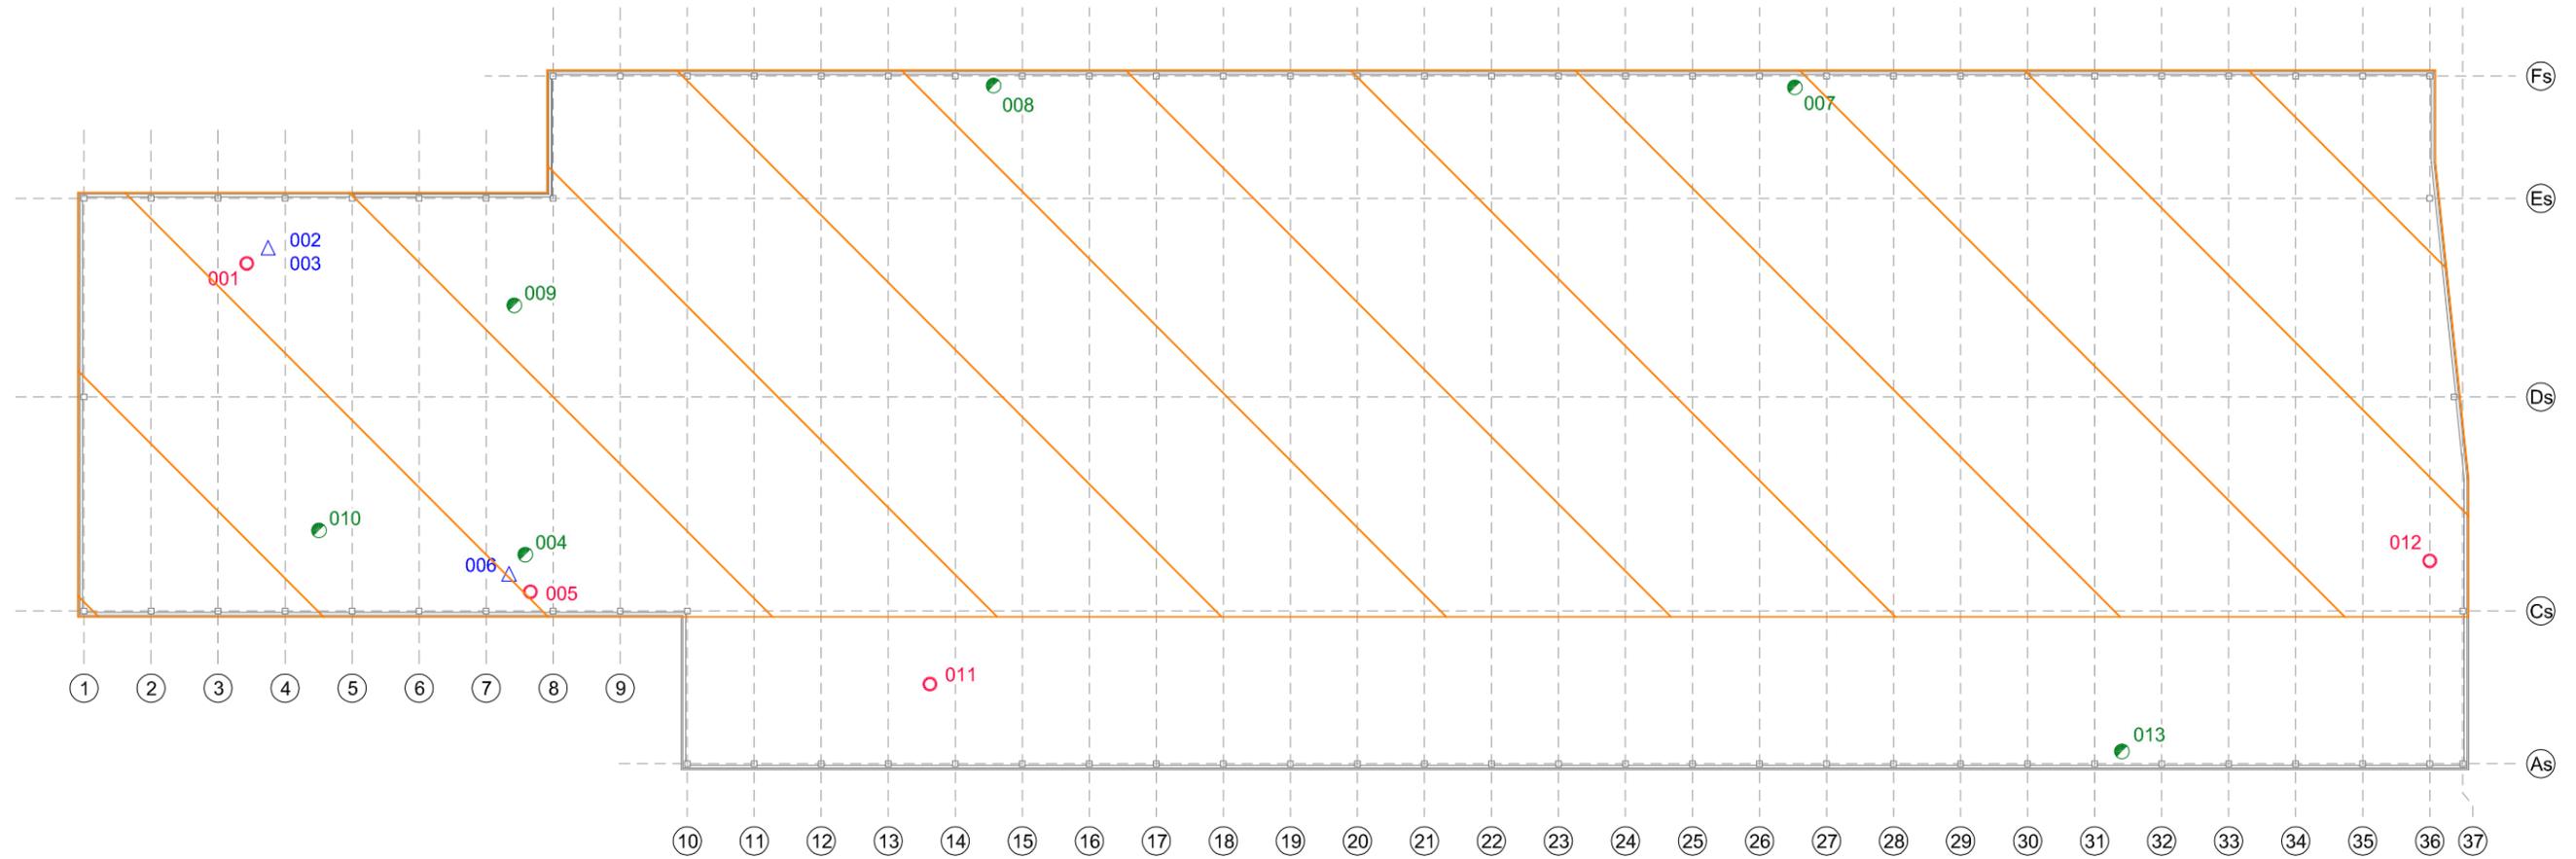
Based on the lab results, asbestos is present in most of the roof deck areas, with the exception of the south bay addition. The full test results from CRA's April 14 field work and subsequent lab tests can be found in Section 4.0 of CRA's report in Appendix B.

The detailed description of materials surveyed, including location, type, approximate quantity, and condition, as well as samples collected and the analytical data are provided in Table 1. The sample locations, and locations of confirmed asbestos in the roofing material are shown on Figure 1. The analytical laboratory reports are provided in Appendix A.
