**Read Jones Christoffersen**  
Consulting Engineers

Suite 500  
144 Front Street West  
Toronto, ON M5J 2L7  
Canada

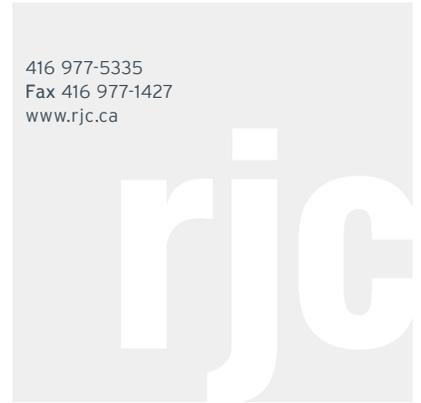
**BUILDING CONDITION ASSESSMENT REPORT**  
**CITY OF STRATFORD COOPER SITE**  
**350 DOWNIE STREET, STRATFORD, ONTARIO**

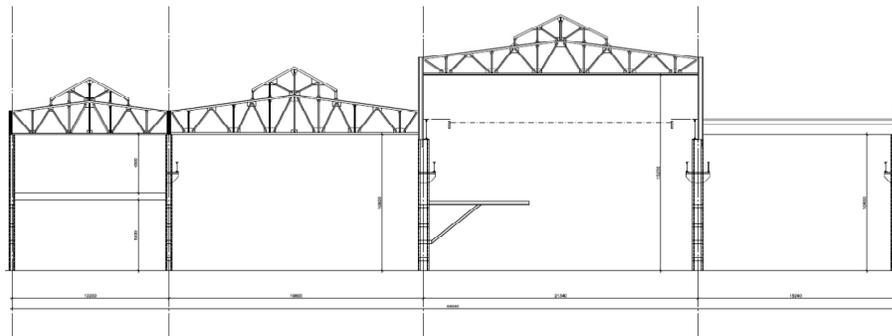
FIGURE #1: TYPICAL BUILDING SECTION

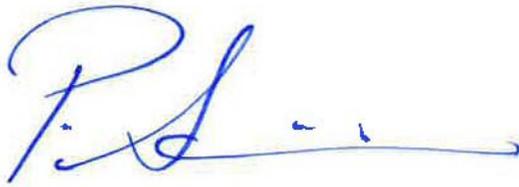
for Carlos Alegre, P.Eng.  
Project Engineer  
Building Science and Restoration

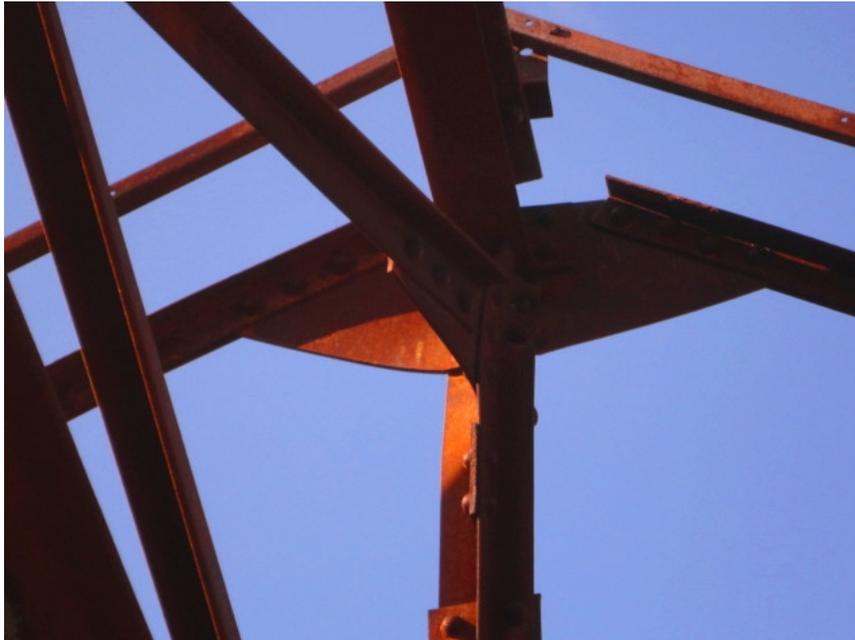
Photo #14: Typical steel corrosion in apex of roof in fire damaged region

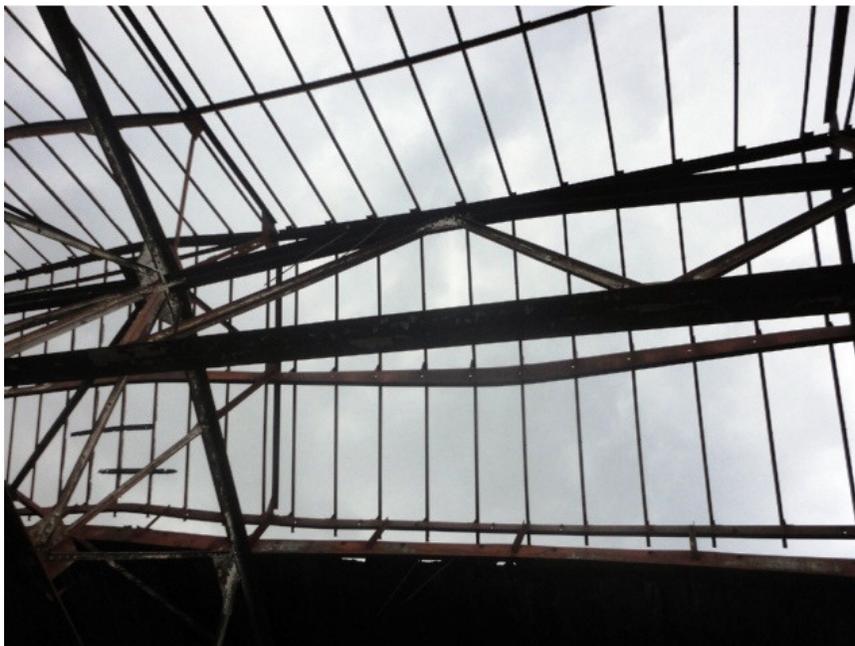
Photo #15: Typical warped purlins in fire damaged region

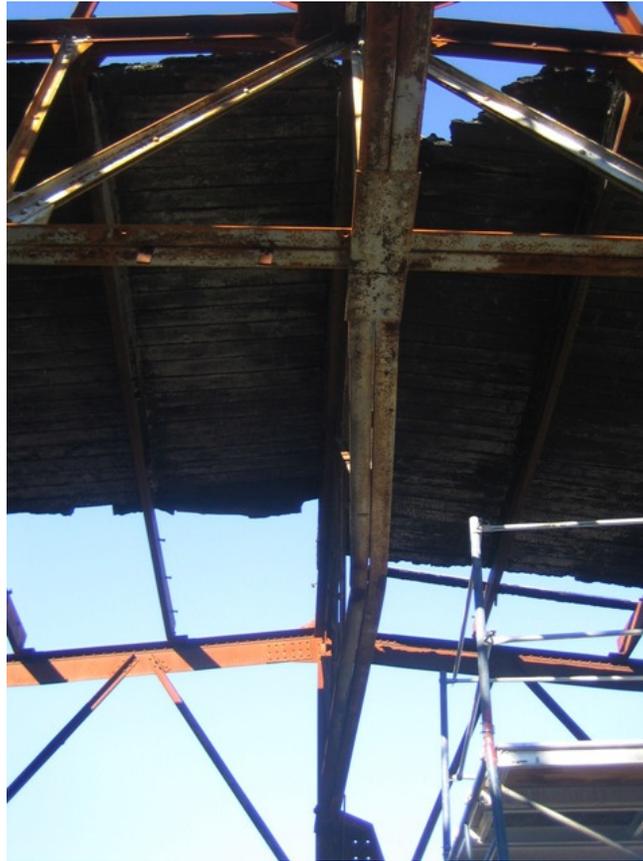
Photo #16: Typical warped tie-truss in fire damaged region

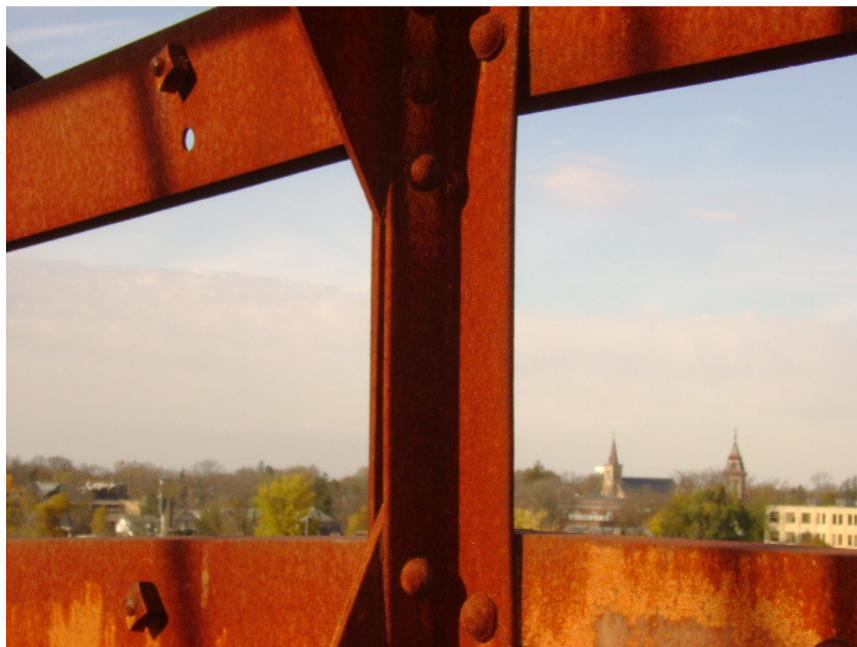
Photo #17: Typical warped apex vertical member in fire damaged region

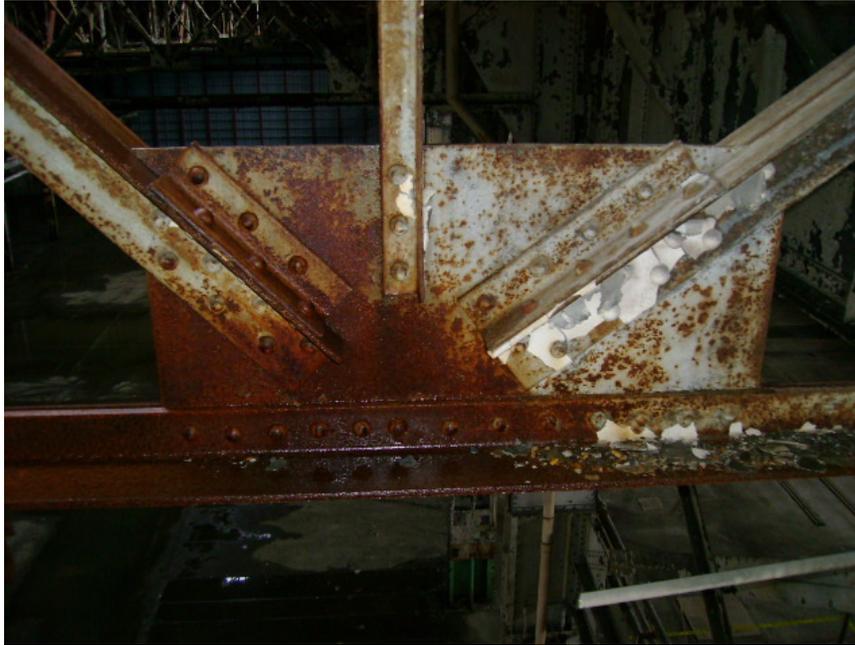
Photo #18: Typical corrosion along bottom chord of roof truss

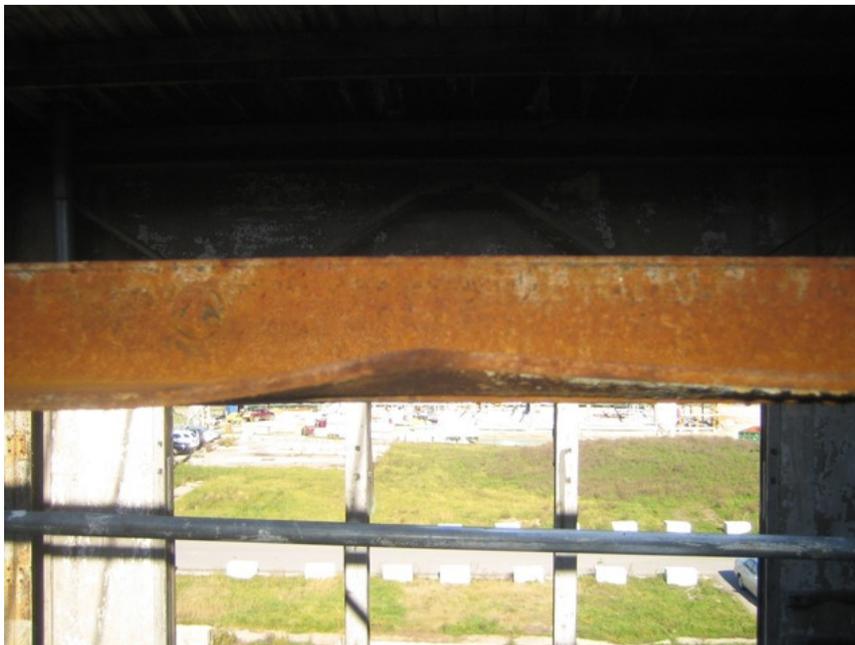
Photo #19: Typical dent/kink in truss member

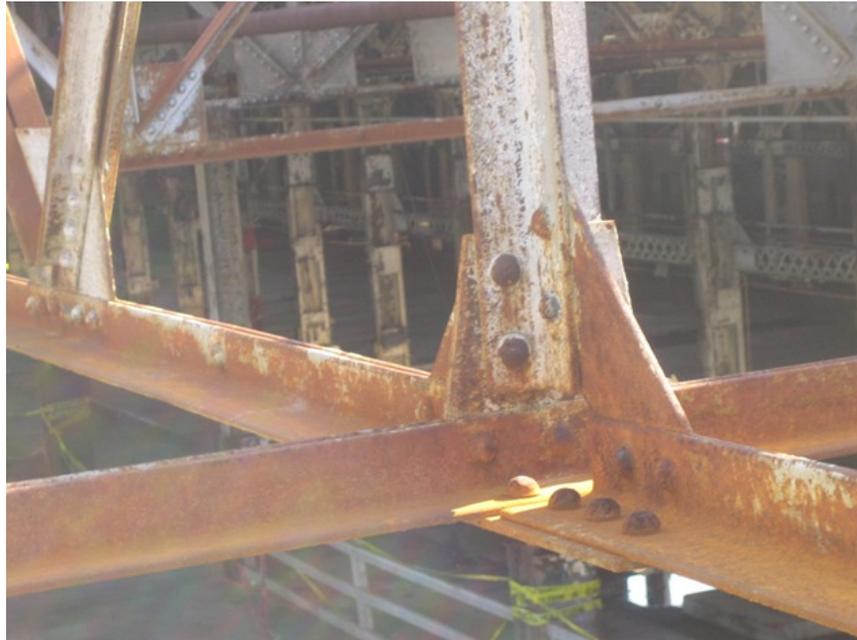
Photo #20: Typical rivet corrosion

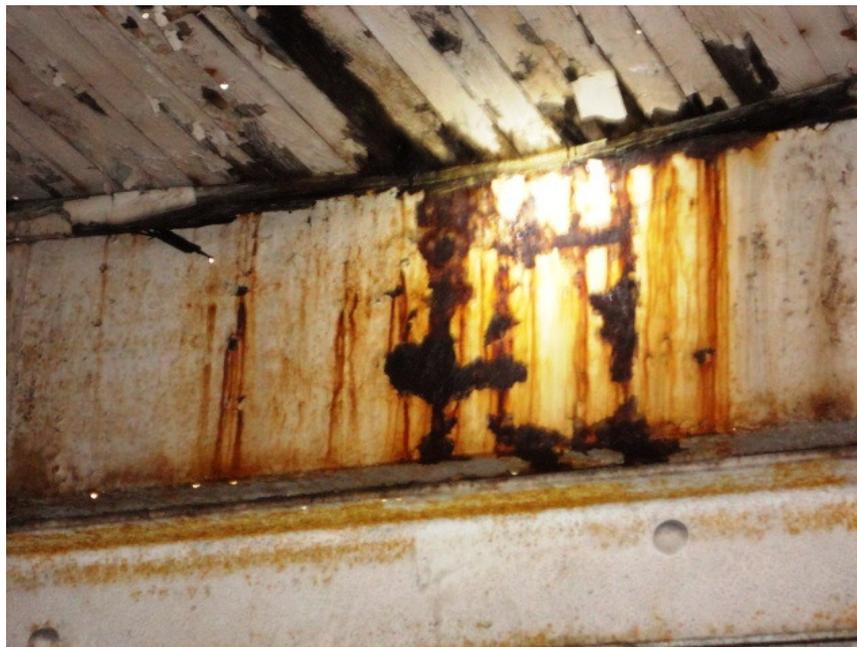
Photo #21: Typical roof leak causing corrosion on top flange of girder in Addition

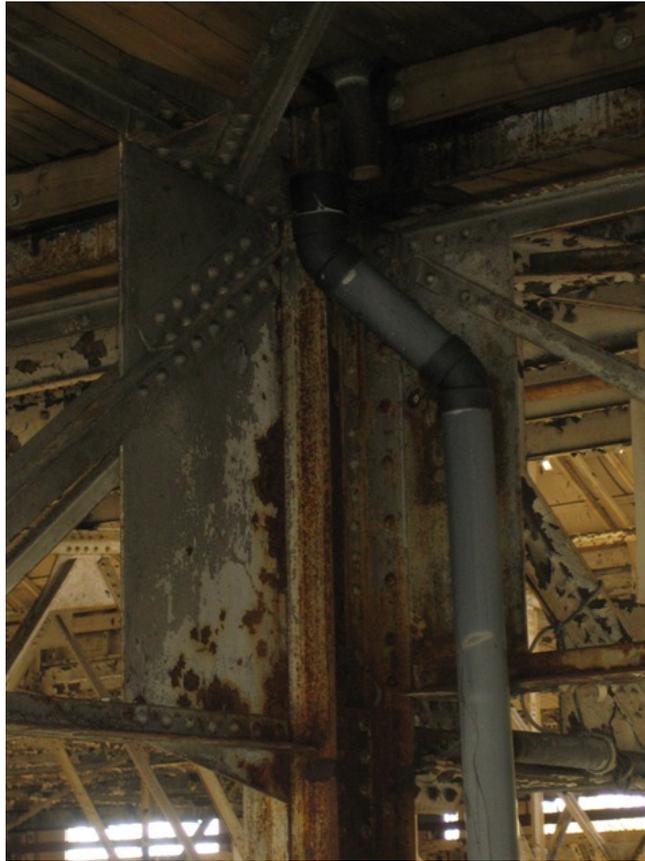
Photo #22: Typical storm water leader and corrosion at top of column

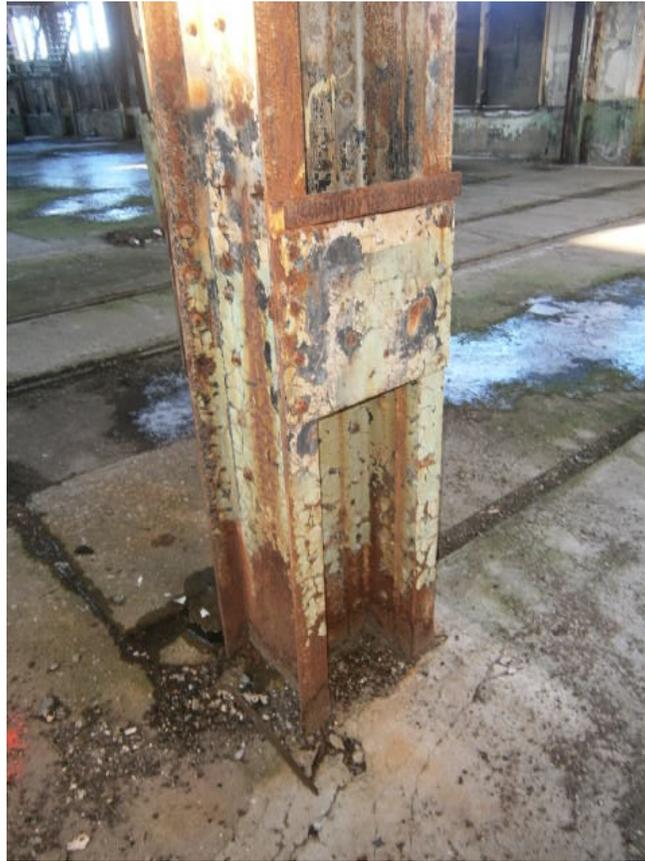
Photo #23: Typical corrosion at column base

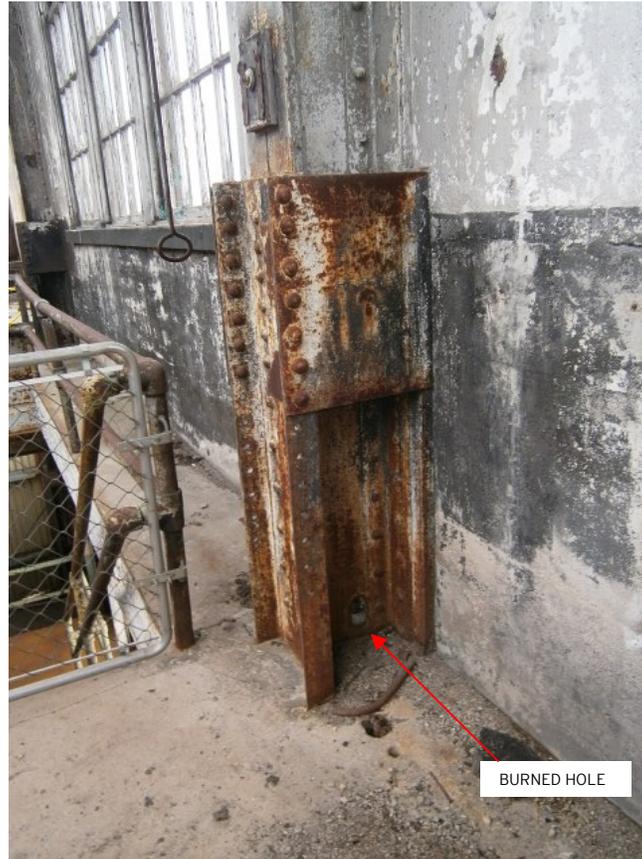
Photo #24: Burned hole through column web

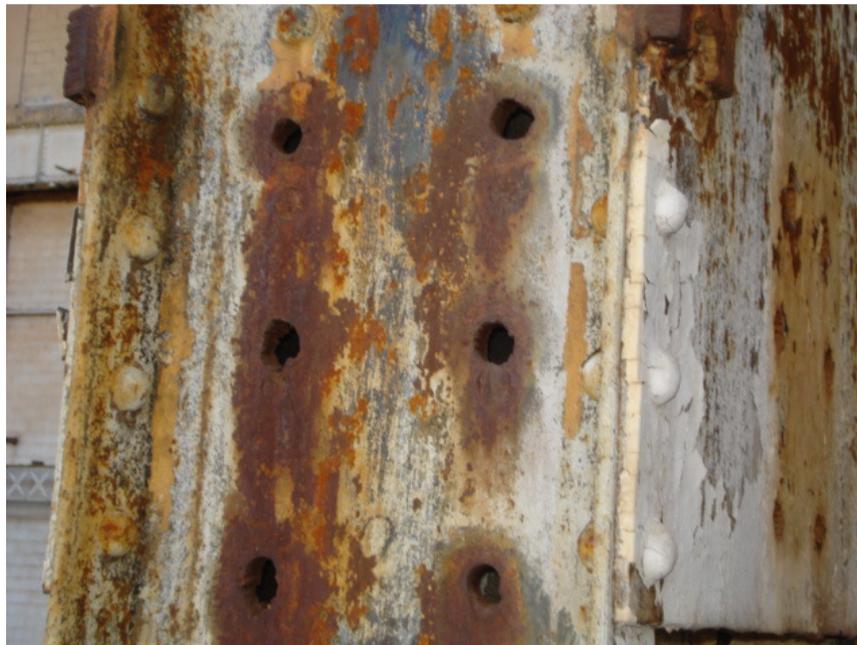
Photo #25: Typical missing rivets on column along gridline Ds

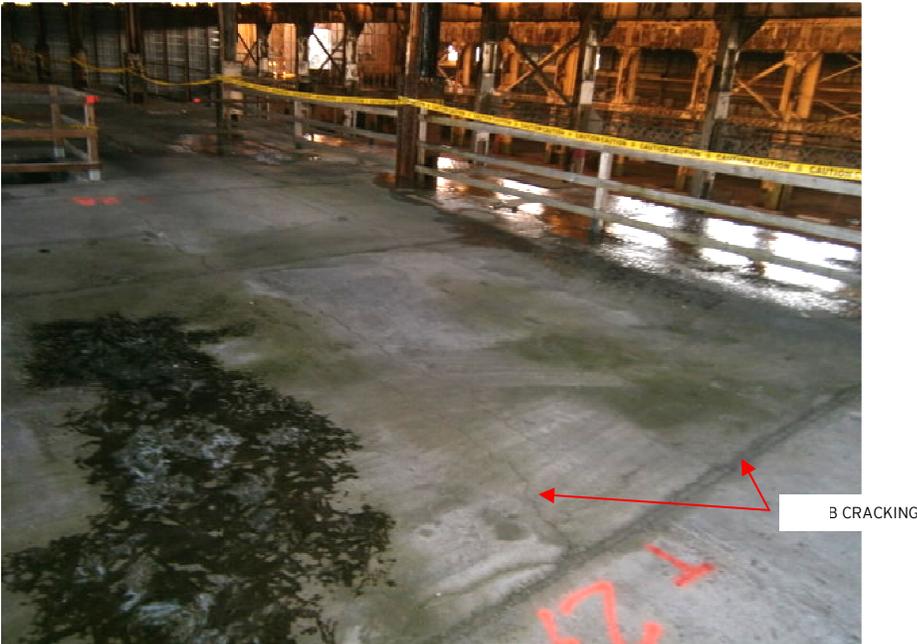
Photo #26: Typical mezzanine slab cracking

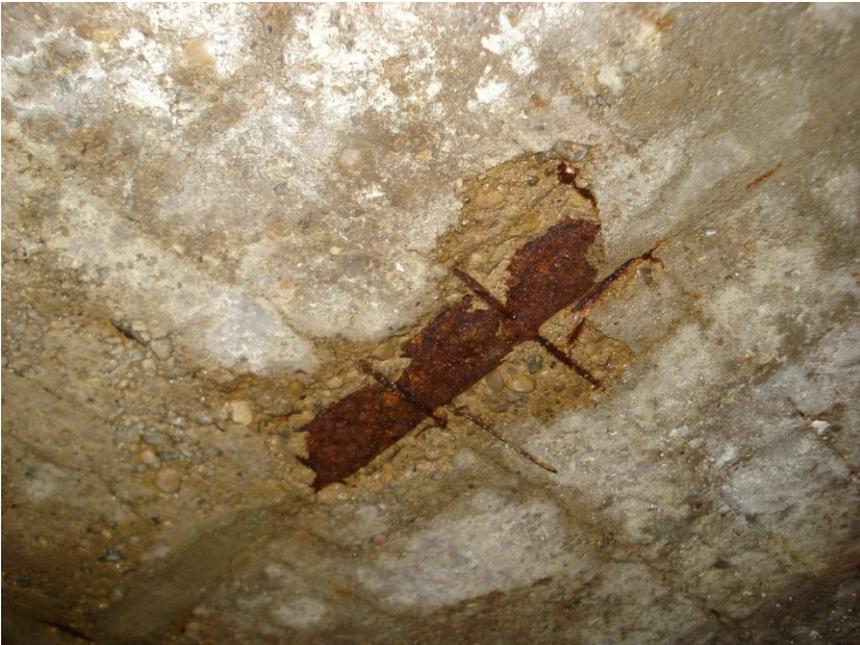
Photo #27: Mezzanine slab soffit delamination and exposed reinforcing steel

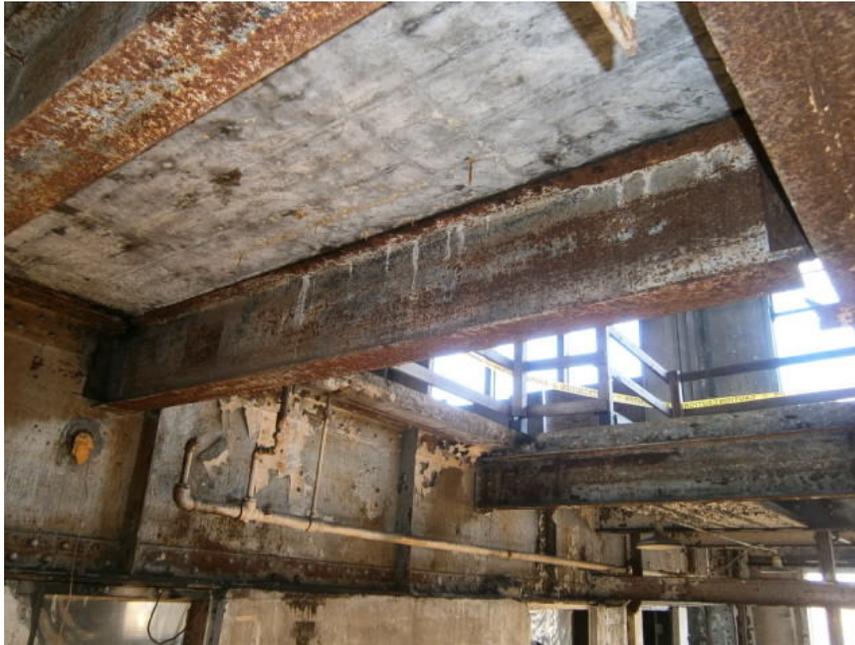
Photo #28: Typical corroded steel and slab soffit deterioration near slab opening

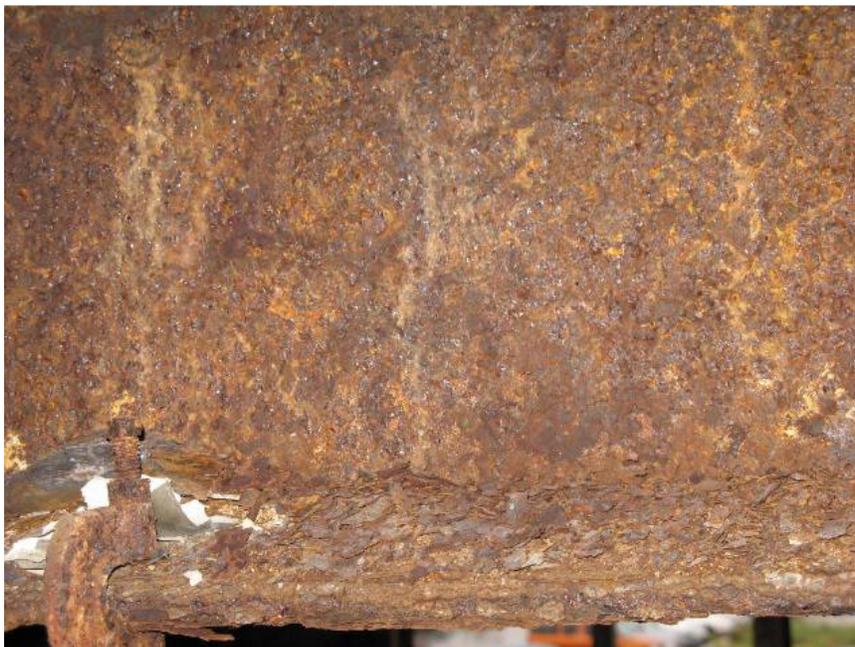
Photo #29: Heavily corroded bottom flange of steel girder below mezzanine slab

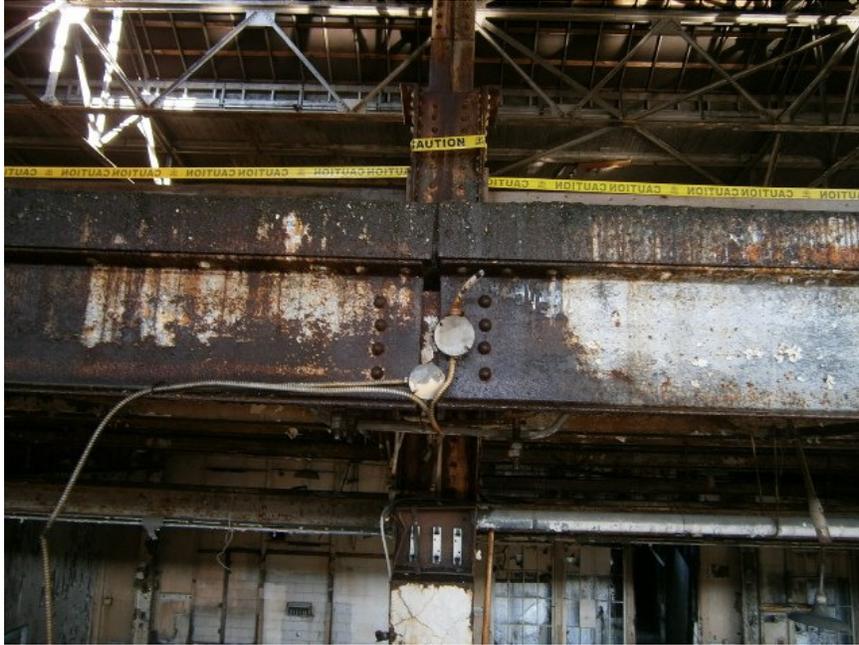
Photo #30: Typical corrosion of steel at mezzanine slab edge

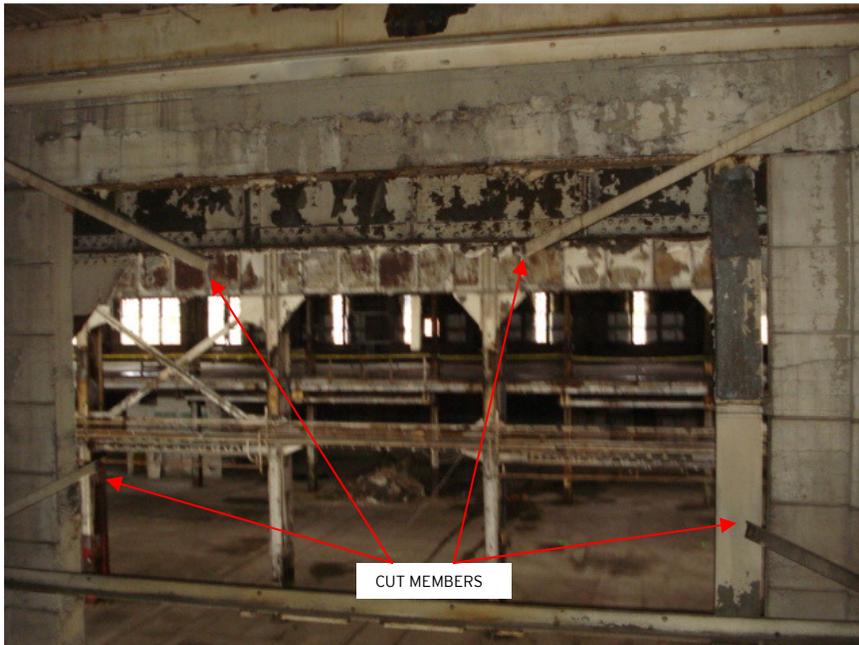
Photo #31: Vertical cross-bracing cut-out in addition

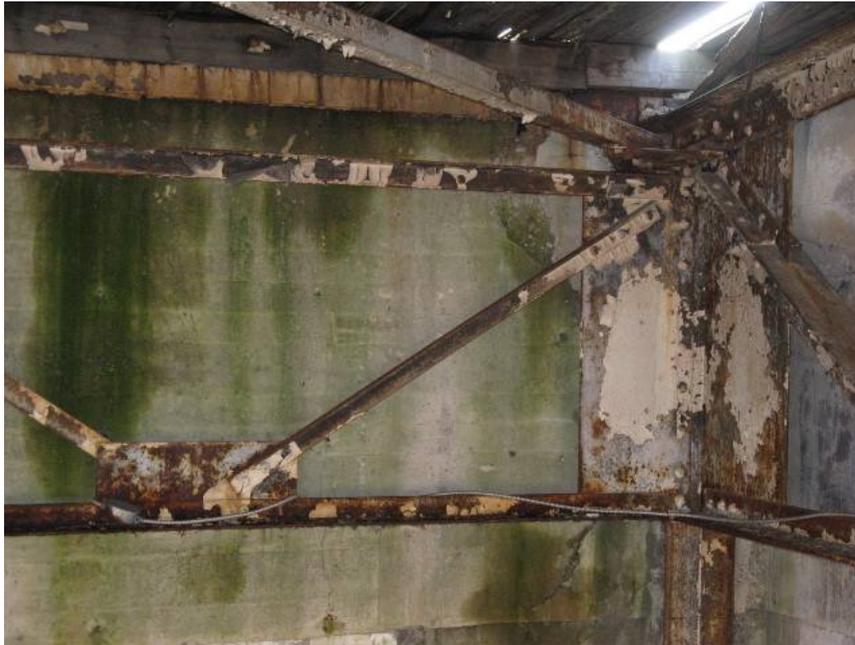
Photo #32: Corrosion at tying truss near grid 'Cs-1'

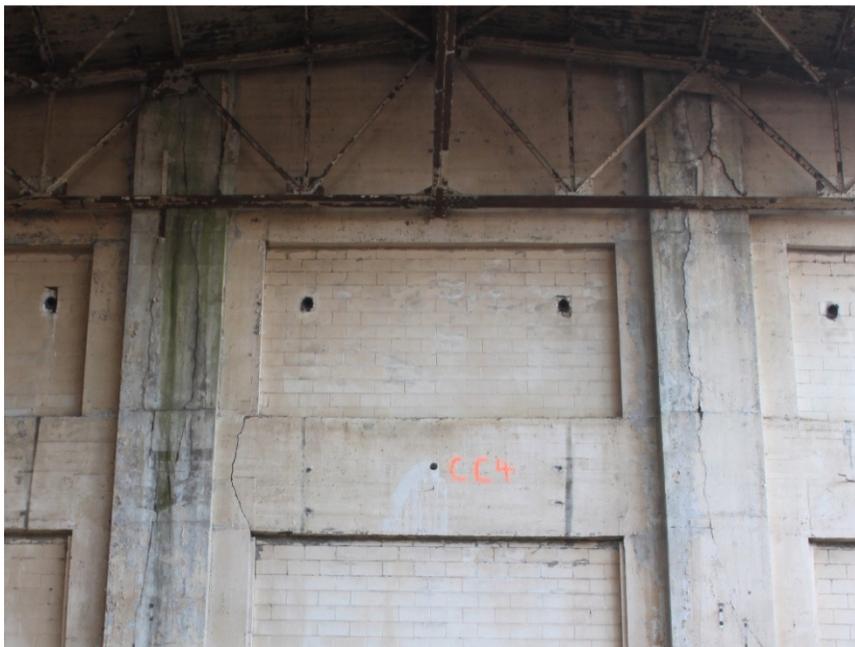
Photo #33: Exterior concrete wall deterioration

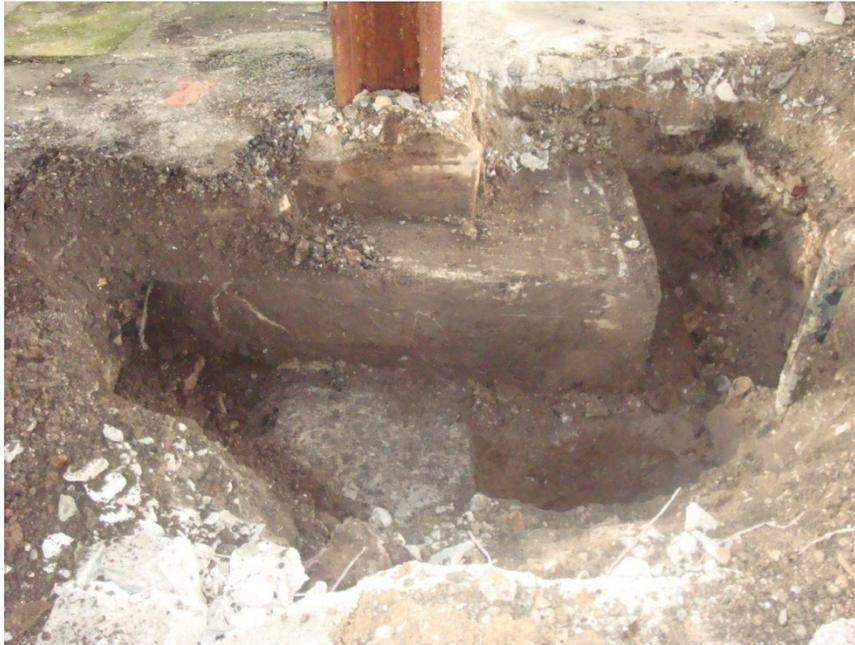
Photo #34: Test Pit #1 - Footing / Caisson Cap

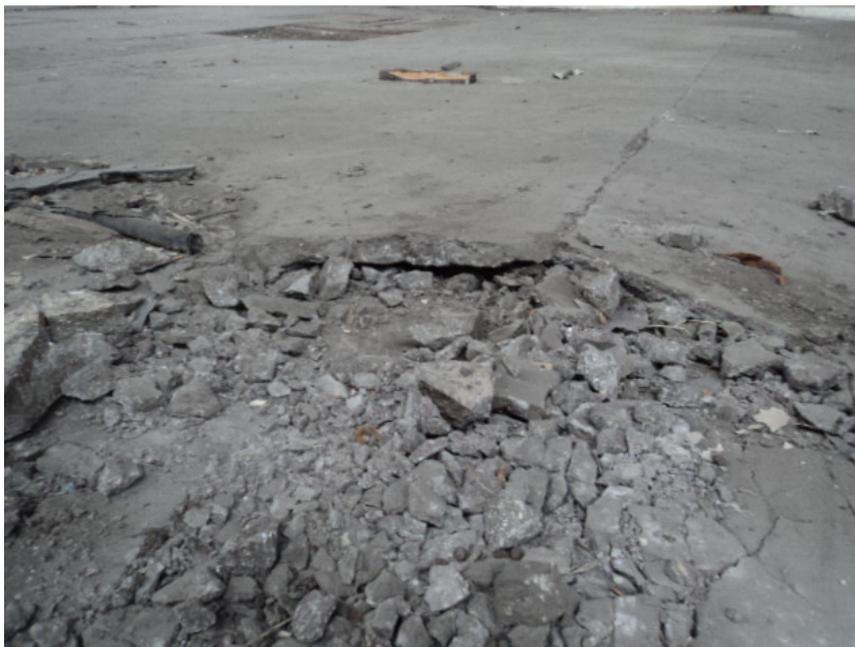
Photo #43: Slab-on-grade area of deterioration/damage

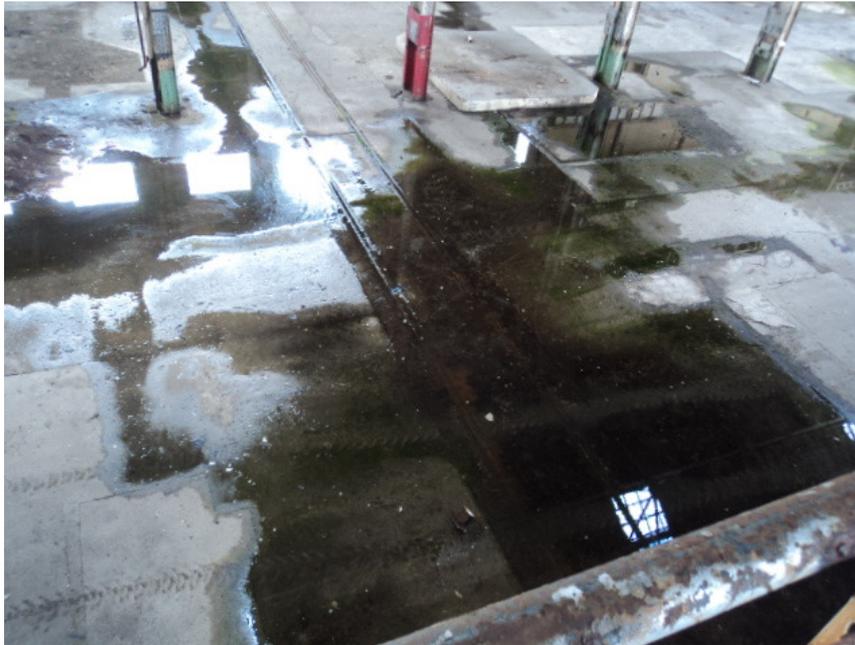
Photo #44: Slab-on-grade area of differential settlement

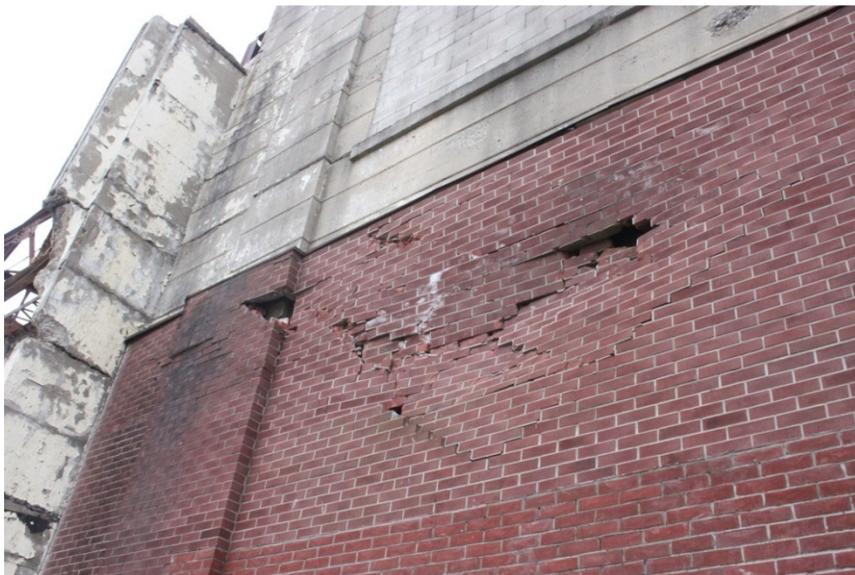
Photo #45: Impact damage and deterioration of exterior brick veneer

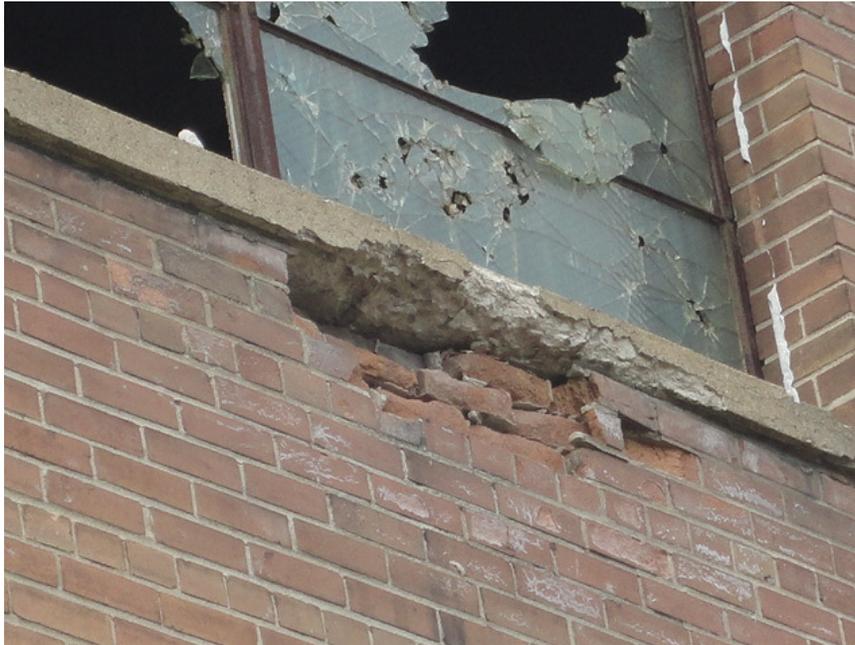
Photo #46: Typical deterioration of concrete sill and masonry below

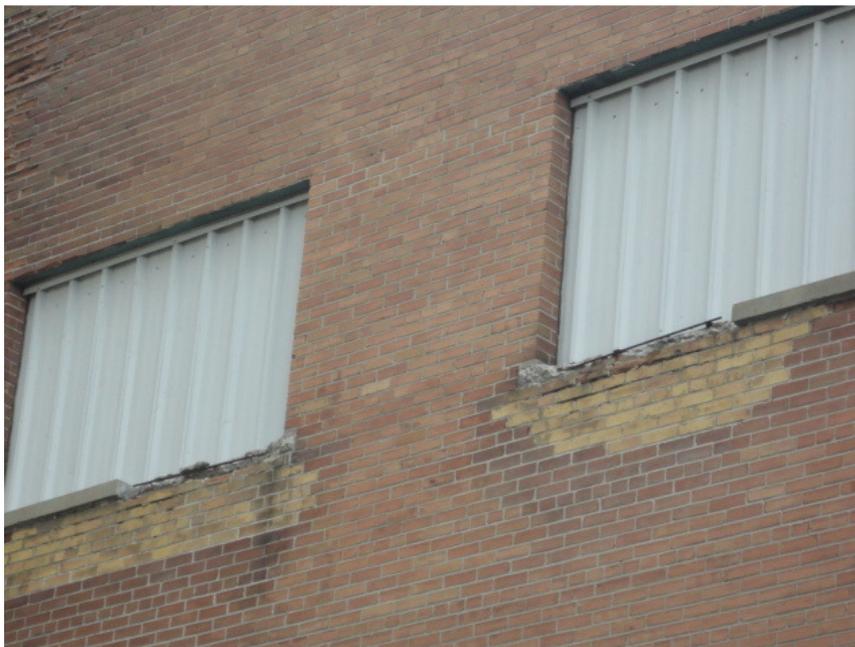
Photo #47: Typical repaired masonry below window sills

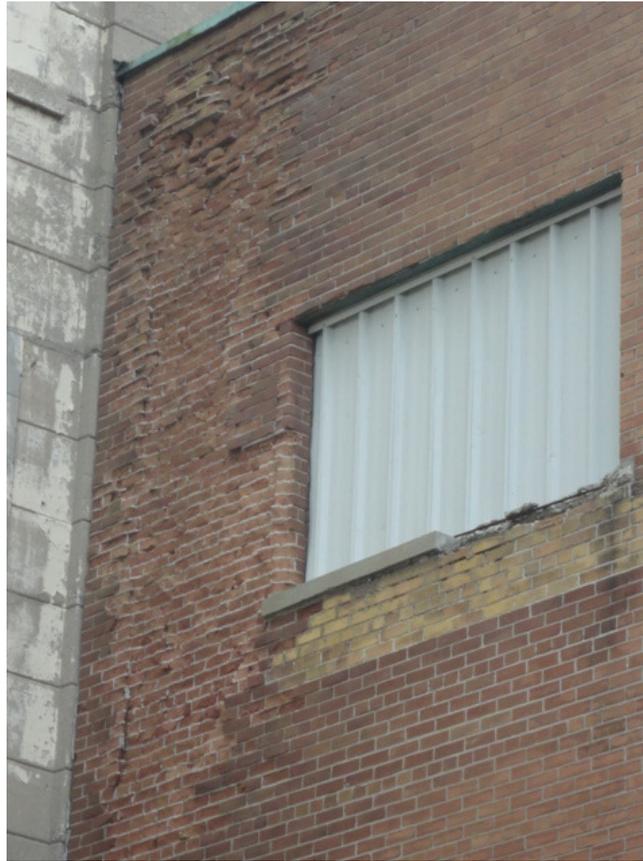
Photo #48: Deterioration of masonry wall at junction with existing wall

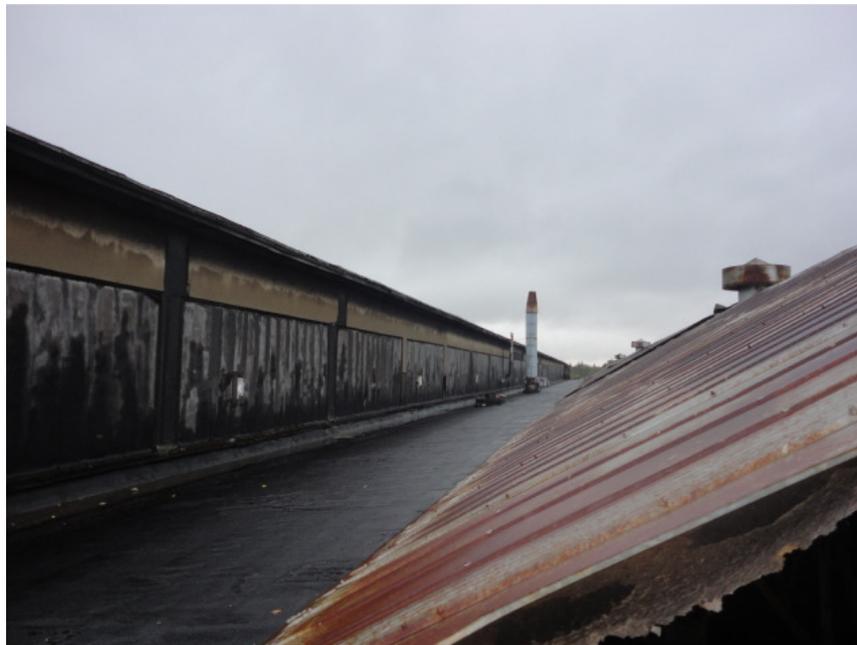
Photo #49: Typical roof assembly and condition

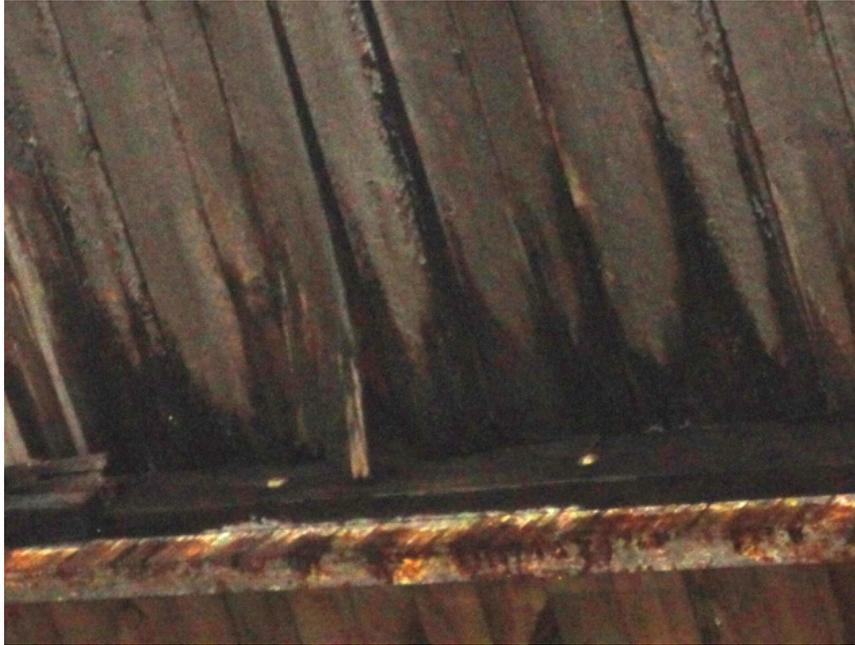
Photo #50: Typical roof deck rotting and deterioration
