RE: Cooper Site Building - 350 Downie Street, Stratford, ON
Costing for Cooper Site Partial Demolition Options

RJC No.: TOR.103282.0013

Appendix 'A'

City of Stratford Cooper Building Proposed Actions - Powerpoint Slides

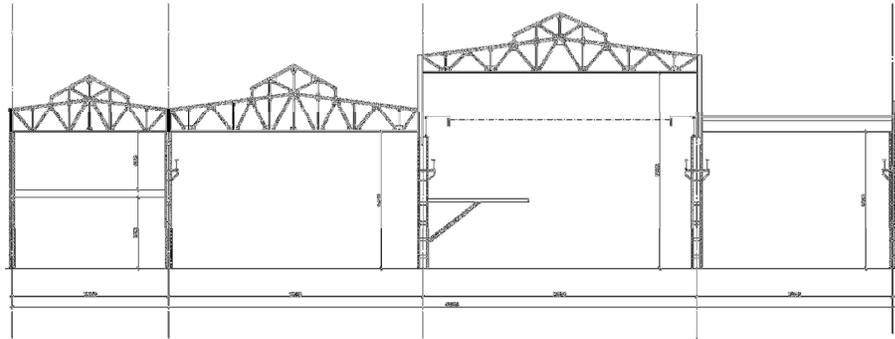
FIGURE #1: TYPICAL BUILDING SECTION

The remaining building is generally arranged with four (4) bays, all of which are open from the ground to the roof structure with the exception of the north-most bay, which includes a mezzanine level (*refer to Figure #1 below*). From north to south, the north-most bay (herein referred to as the "mezzanine bay") is approximately 615-ft long by 40-ft wide and 50-ft high to its peak. The next bay south (herein referred to as the "low bay") is approximately 770-ft long by 65-ft wide at a similar height of 50-ft to its peak. The 3rd bay south (herein referred to as the "high bay") is approximately 780-ft long by 70-ft wide and 67-ft high to its peak. Finally, the south-most bay (herein referred to as the "addition bay") is approximately 580-ft long by 50-ft wide and 38-ft high to the roof surface.

The building structure utilizes traditional structural steel construction with cast-in-place concrete foundations and footings. Currently, the exterior walls are typically a concrete frame fastened back to the building columns with large window openings, which have since been infilled with concrete block unit masonry. The building is clad with corrugated metal siding. The current roofing system consists of mopped multi-ply asphalt roofing on solid 2" thick tongue and groove wooden roof decking on the low slope roofs. The apex roofs are typically sheet metal supported by wood strapping and metal channel grits.

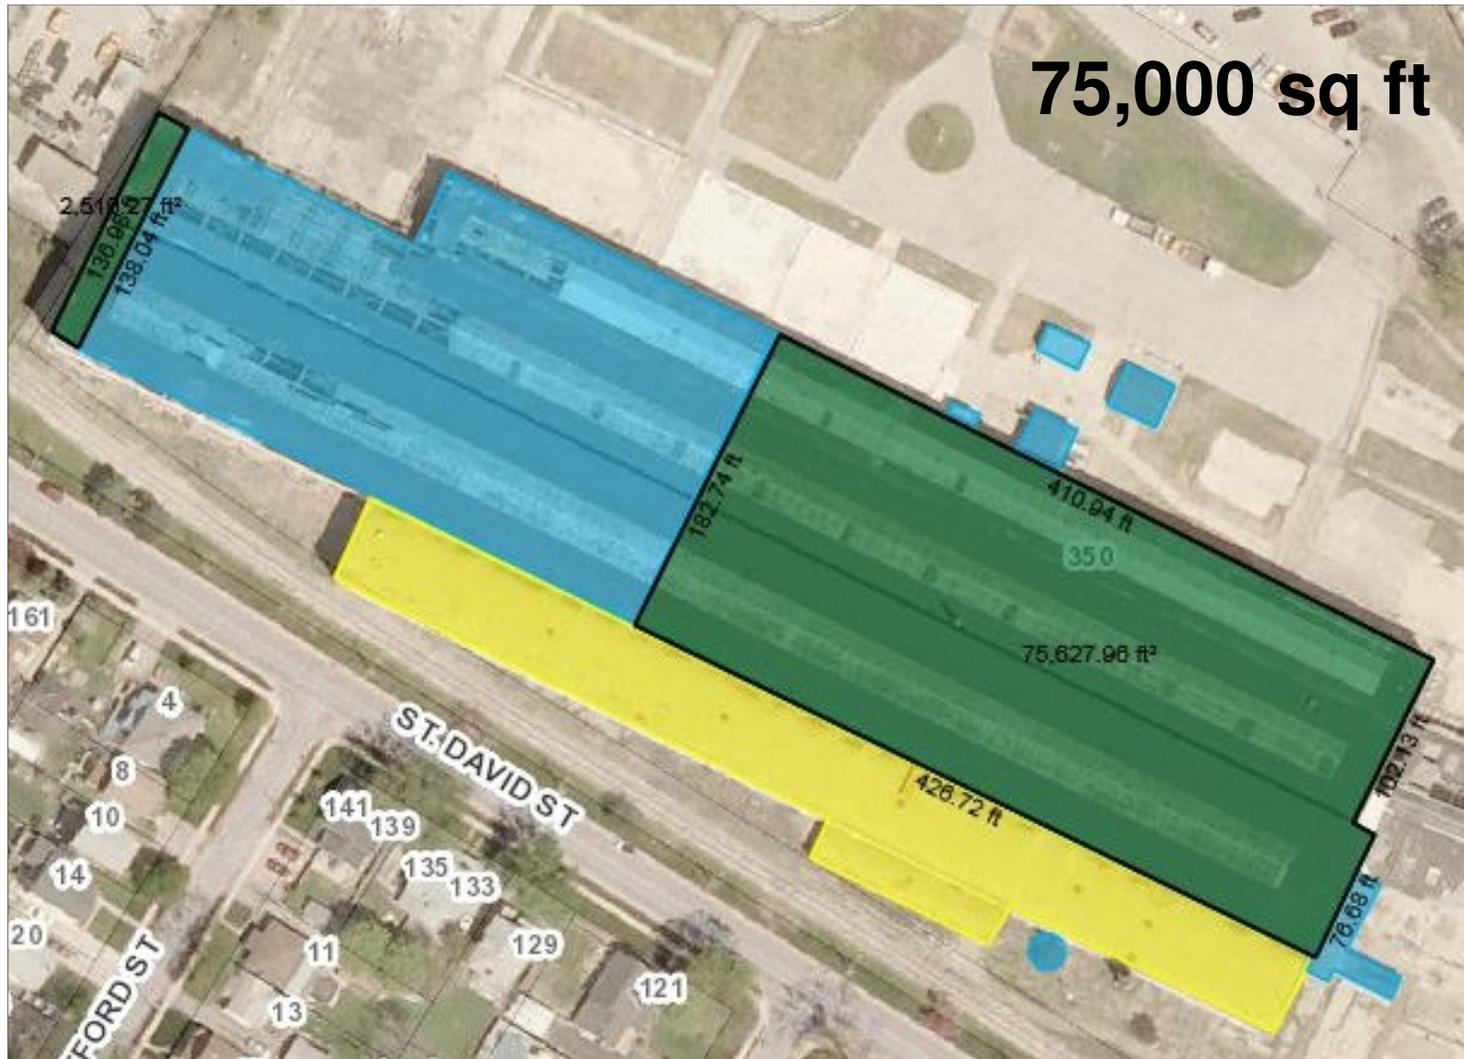
Cooper Building – 4 May 2015

1. **Retain 75,000 Square Feet of the building ([green](#)) with west wall, steel, and date stone;**
2. Remove only loose roof material from balance of building for health and safety;
3. Because Heritage Stratford did not include the Annex ([yellow](#)) in reasons for designation, the Annex is to be demolished in the future because it has no heritage value;
4. We will contact the railway to discuss permitted uses on the site and the 30 meter setback;
5. Council will review the costing of available options and public uses as discussed at subcommittee on 30 April;
6. Commercial relator to market remaining 75,000 square feet as adaptive re-use to prospective developers until 30 September;
7. Remove cladding, loose material from building, and all outside buildings ([blue](#));
8. Fencing issue to be decided by the Chief Building Official as per the Unsafe Order.

Refer to Appendix A for Cooper Building Site Plan and documentation received from the City of Stratford . This option includes the demolition of the west half of the building up to approx. Gridline 18 (highlighted in blue). This option also includes the demolition of the west half of the south addition annex (highlighted in yellow) up to approx. Gridline 18. It includes the demolition and removal of all the roof deck materials, steel roof superstructure, mezzanine level, portion of steel columns above grade, and north and south cladding walls. In total, the building area to be demolished is approximately 70,000 sq.ft. or 44 % of the total building footprint. For structural stability of the east half of the building (highlighted in green), the
