May 21, 2015

RE: Cooper Site Building - 350 Downie Street, Stratford, ON
Roofing Components Visual Review
Including Hazardous Materials Abatement Costs

RJC No.: TOR.103282.0012

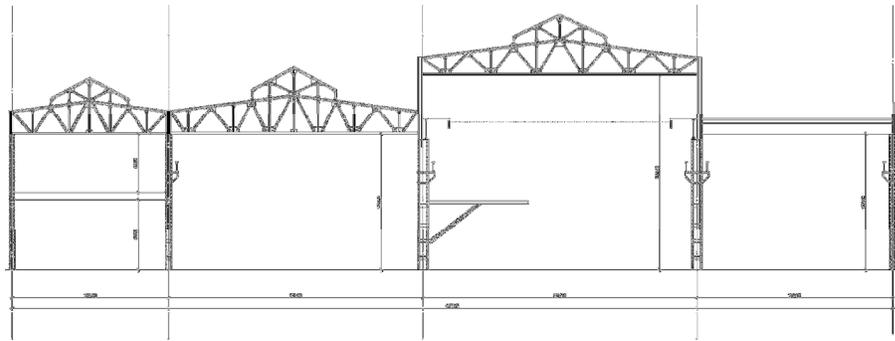
FIGURE #1: TYPICAL BUILDING SECTION

The remaining building is generally arranged with four (4) bays, all of which are open from the ground to the roof structure with the exception of the north-most bay, which includes a mezzanine level (*refer to Figure #1 below*). From north to south, the north-most bay (herein referred to as the "mezzanine bay") is approximately 615-ft long by 40-ft wide and 50-ft high to its peak. The next bay south (herein referred to as the "low bay") is approximately 770-ft long by 65-ft wide at a similar height of 50-ft to its peak. The 3rd bay south (herein referred

to as the “high bay”) is approximately 780-ft long by 70-ft wide and 67-ft high to its peak. Finally, the south-most bay (herein referred to as the “addition bay”) is approximately 580-ft long by 50-ft wide and 38-ft high to the roof surface.

In plan, the main bays are denoted by lettered gridlines As, Cs, Ds, Es, and Fs, spaced in the north-south direction as per the bay width noted above. The transverse gridlines are numbered and identify the column spacing in the east-west direction, generally at 22' centres.
