2024

ANNUAL PERFORMANCE REPORT

City of Stratford Stormwater
Management System

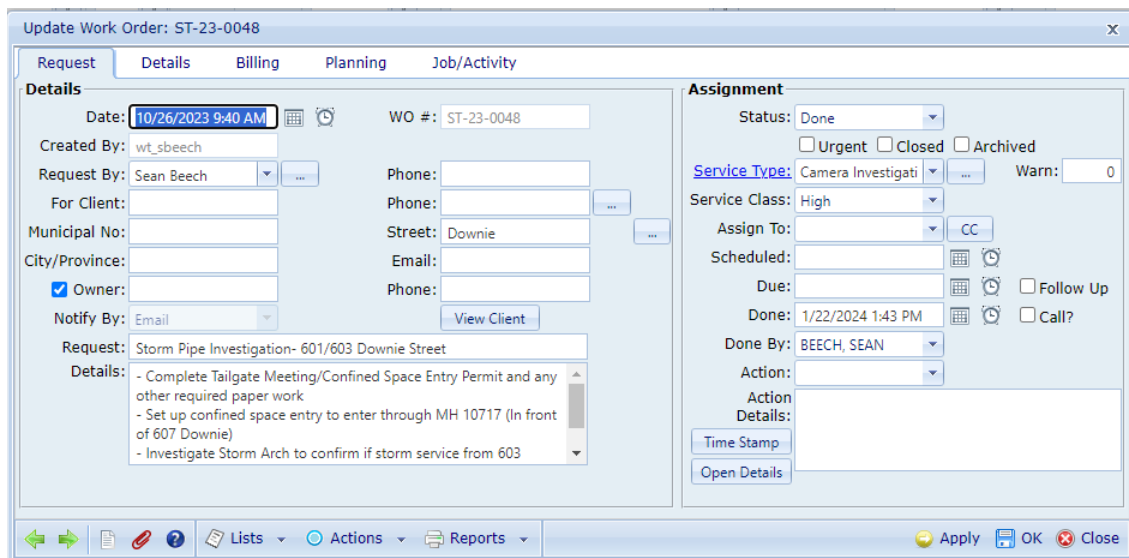
Examples of e.Ris Digital Forms and Maintenance Tracking:

Comments & History	Value
Date and Time		2023-06-26 10:45:16
Inspection Type		Semi-Annual Inspection
SWM Pond Type		Wet Pond
SWM Pond Name		Crane Ave SWMPs
Asset ID		341300004, 341300005, 34
Vegetation Concerns		No
Obstructions of the Inlet and/or Outlet?		Yes
Evidence of Spills and or Grease Contamination?		No
Presence of Trash Build-Up?		No
Presence of Algae?		Select value...
Presence of Invasive Species?		None Observed
